TEST FILLS FOR ROCK-FILL DAMS

ARMY ENGINEER WATERWAYS EXPERIMENT STATION
VICKSBURG, MISSISSIPPI

MISCELLANEOUS PAPER S-73-7

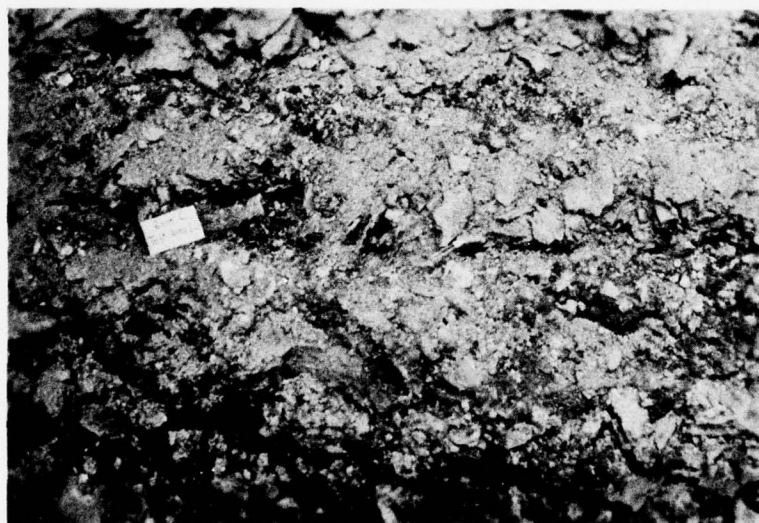
Fig. 11. Inspection trench, Zone C, test area 20, partly weathered shale, Beltzville test fill

b. Closeup view

- d. Inspection trenches. Photographs of inspection trenches in each zone are shown in figs. 11 and 12. These photographs

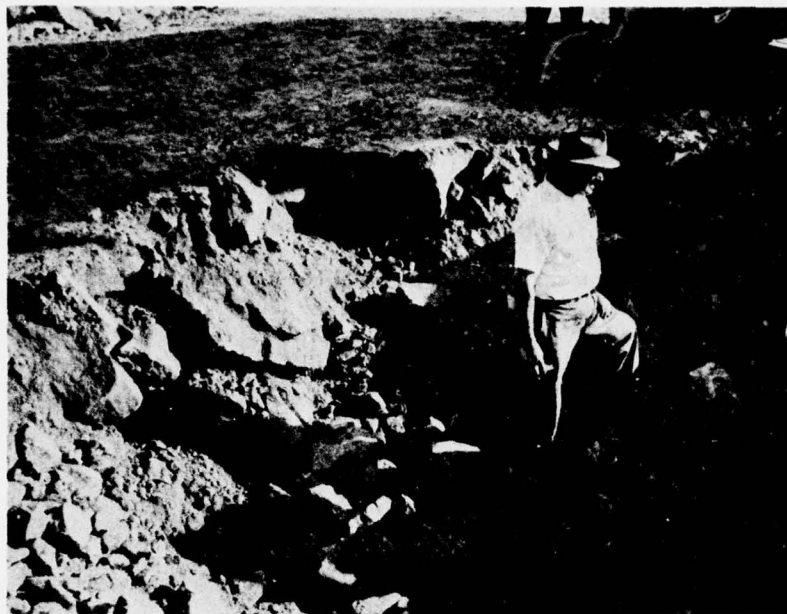
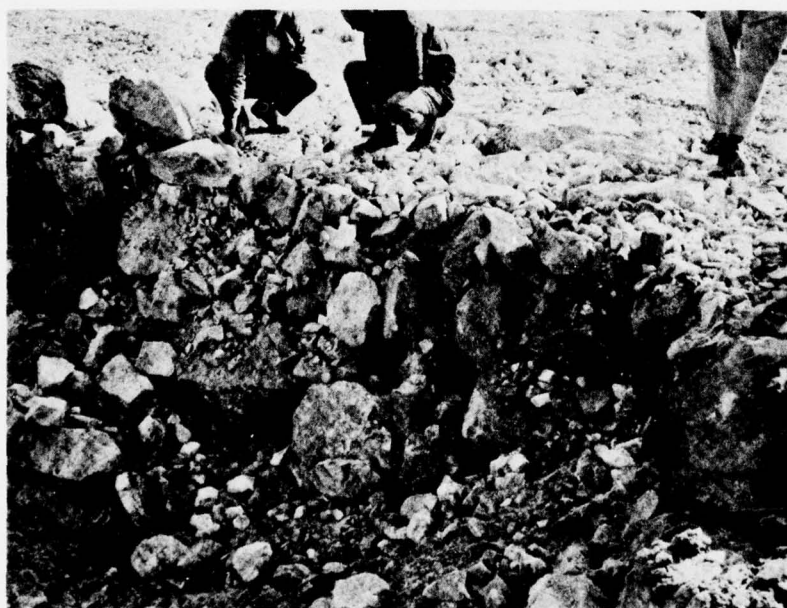
Fig. 18. Inspection trenches, Laurel test fill

a. Second 3-ft lift

b. Second 4-ft lift

- c. Inspection trenches. Visual observations of the inspection trenches revealed the following: (1) the 2-ft lift (lift 1, section 3) had practically no voids, being choked throughout by fines; (2) the upper 12 in. or so of both 3-ft lifts (section 2), the first 4-ft lift (section 1), and the 5-ft lift (lift 2, section 3) contained considerable amounts of fines, while the lower portions contained few fines but satisfactory rock-to-rock contact was in evidence; and (3) the second 4-ft lift (section 1), where plus 3-in. material was placed, revealed a much better distribution of fines throughout its entire depth. An inspection trench in the second 4-ft lift is compared to one in the second 3-ft lift in fig. 18; the greater number of fines in the 3-ft lift is evident.

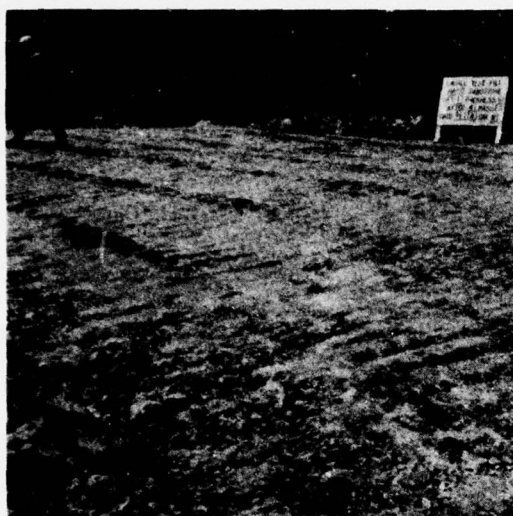
5-ft lift (quarry run)

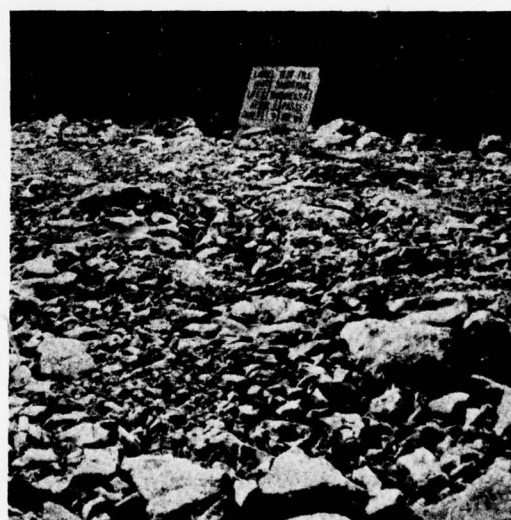
Second 4-ft lift (plus 3 in. only)

b. After six passes

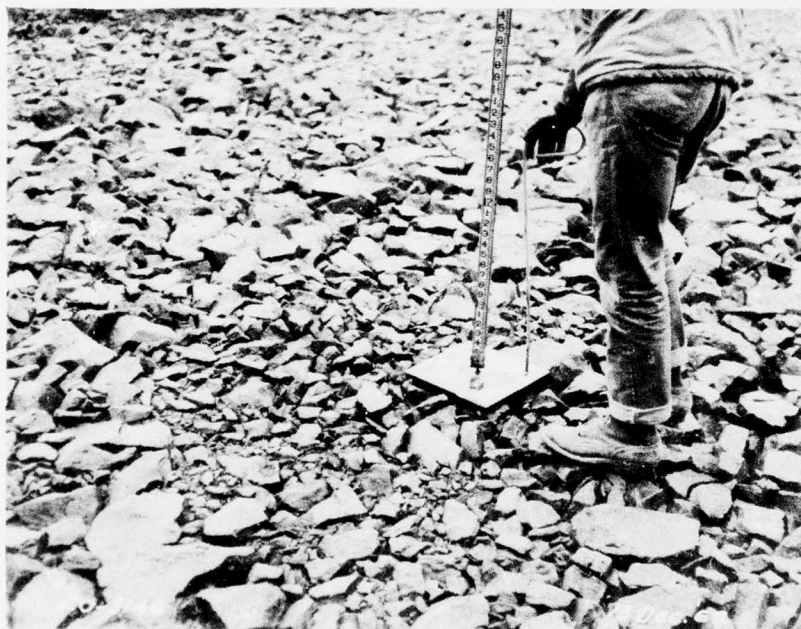
Fig. 27. Apparatus for taking level readings, Cougar test fill

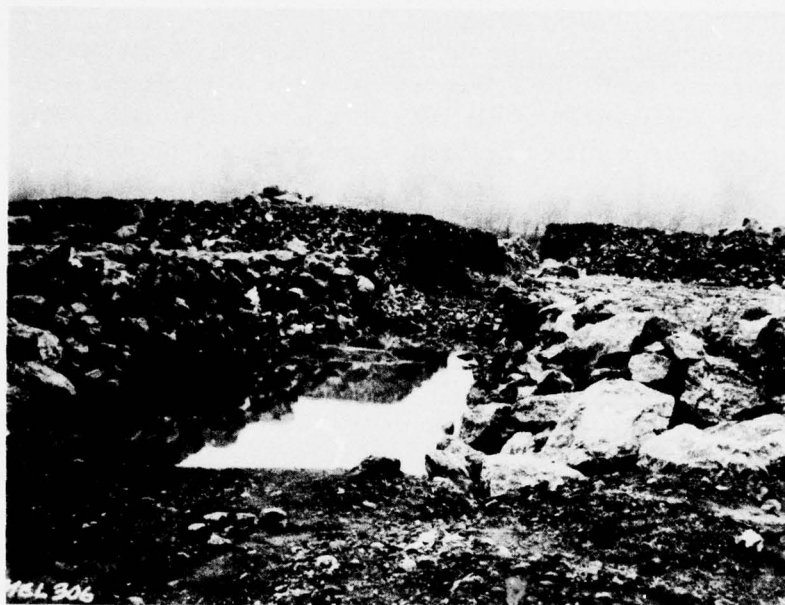
View of transverse cut through rock test fill embankments.
From front to back:

<u>Test Fill No.</u>	<u>Description</u>
1	Weathered rock (6- to 18-in.)
2	Weathered rock (Minus 6-in. transition)
3	Unweathered rock (Minus 6-in. transition)
4	Unweathered rock (6- to 18-in.)

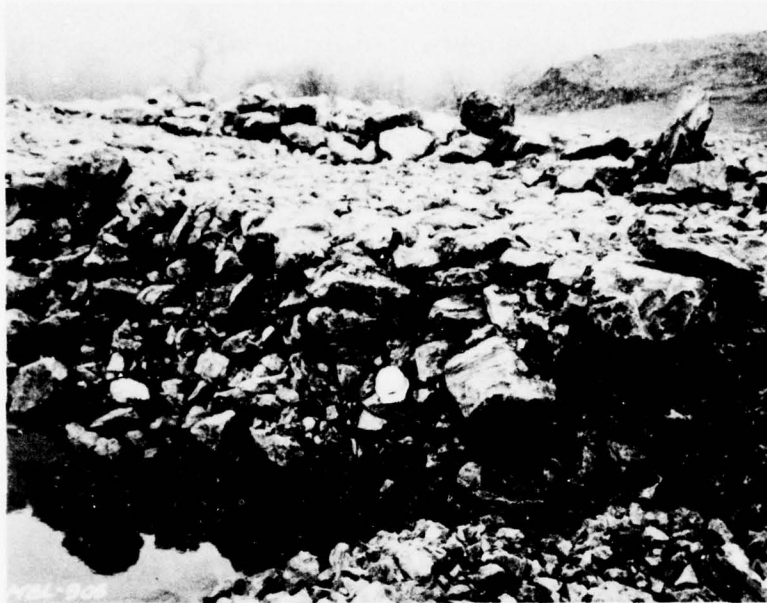
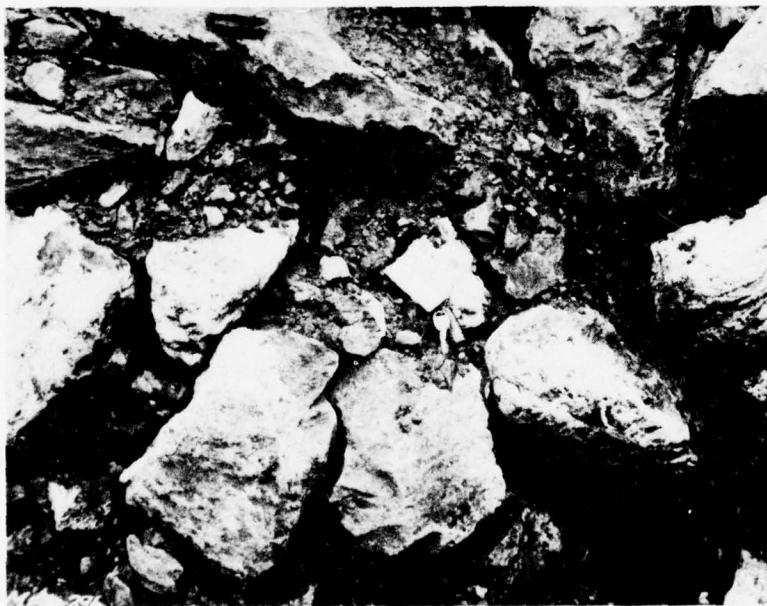
Fig. 41. Inspection trench, test fill 1, New Melones test fill

a. Section of rock test fill 1
(6- to 18-in. weathered rock)

b. Closeup view of rock test fill 1
(6- to 18-in. weathered rock)

were punched down into the smaller surrounding rock. Observation of the compacted rock fill in the inspection trench revealed a marked uniformity of appearance throughout the entire depth of the fills. There were no planes of demarkation at the lift boundaries, and the rock was well interlocked. Fines appeared to be well distributed in the voids. Photographs of the sections through test fills 1 and 4 are shown in figs. 41 and 42.

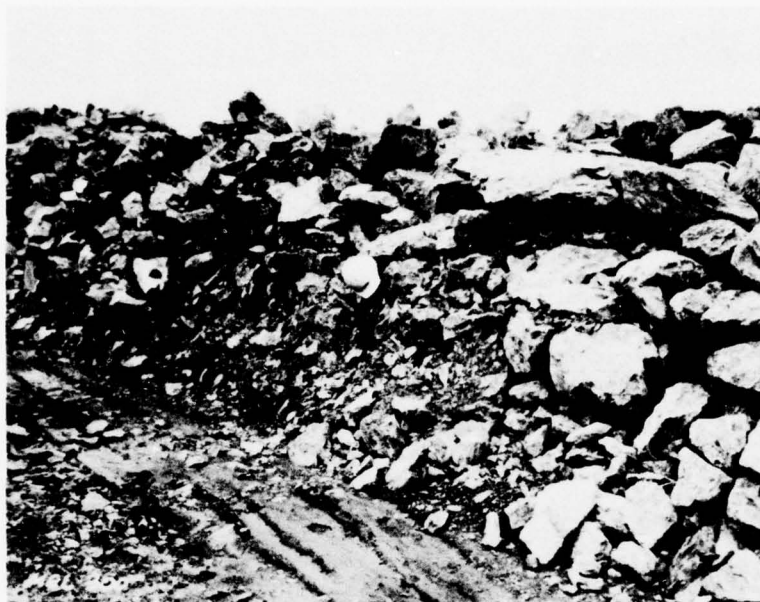
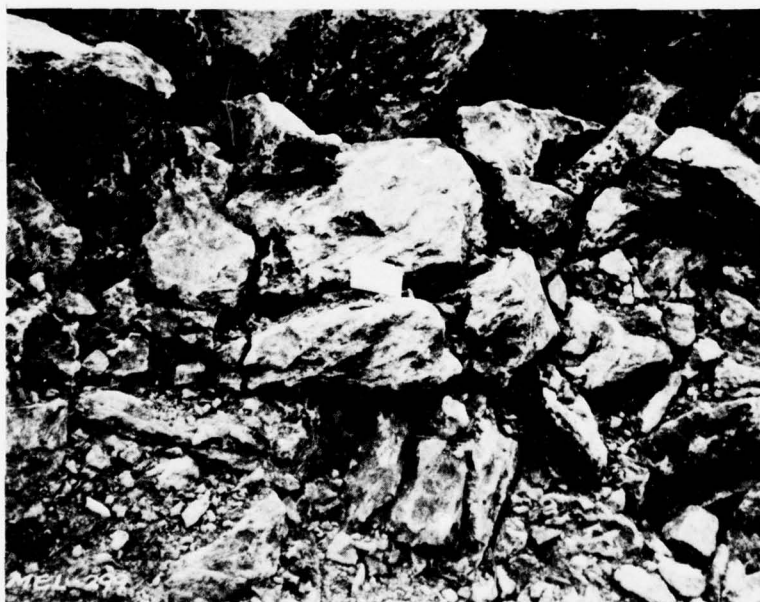
Fig. 42. Inspection trench, test fill 4, New Melones test fill

a. Section of rock test fill 4
(6- to 18-in. unweathered rock)

b. Closeup view of rock test fill 4
(6- to 18-in. unweathered rock)

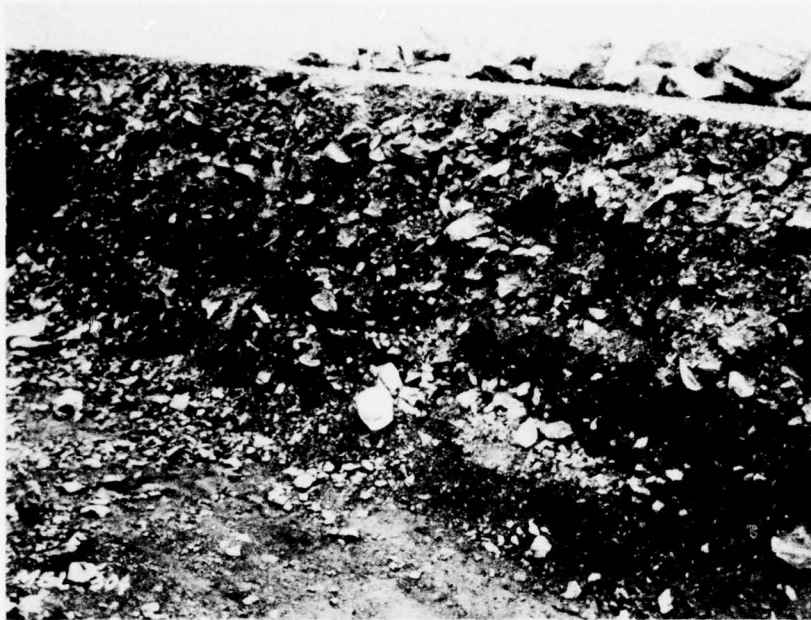
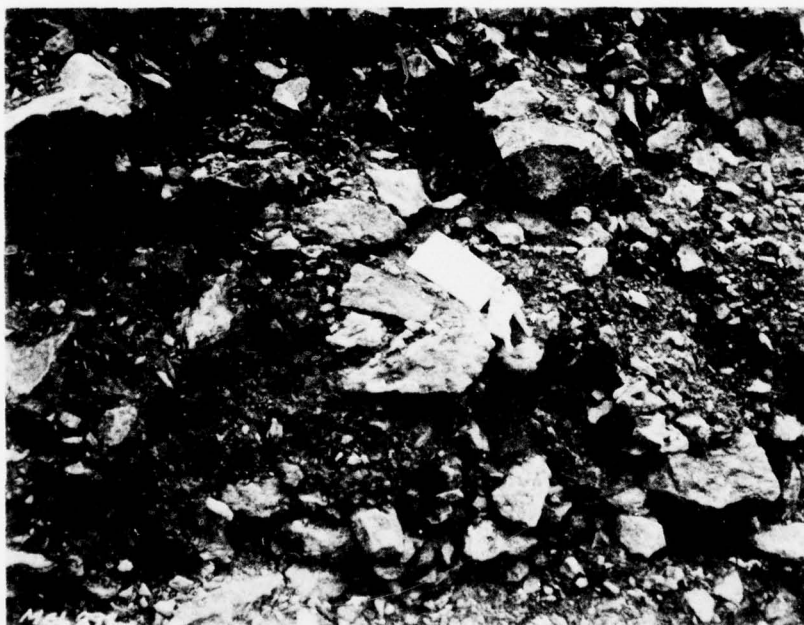
a. Section of rock test fill 2
(minus 6-in. weathered rock transition)

b. Closeup view of rock test fill 2
(minus 6-in. weathered rock transition)

Fig. 43. Inspection trench, test fill 2, New Melones test fill

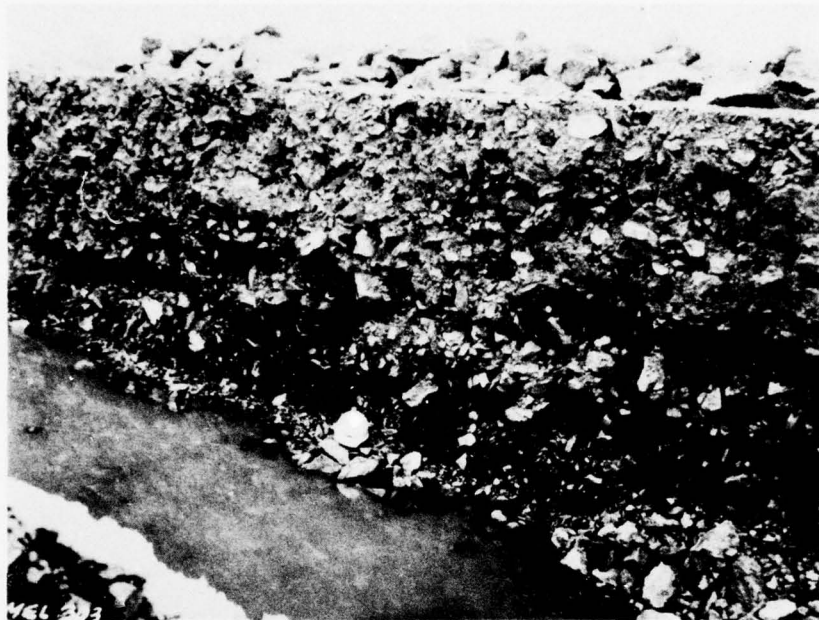
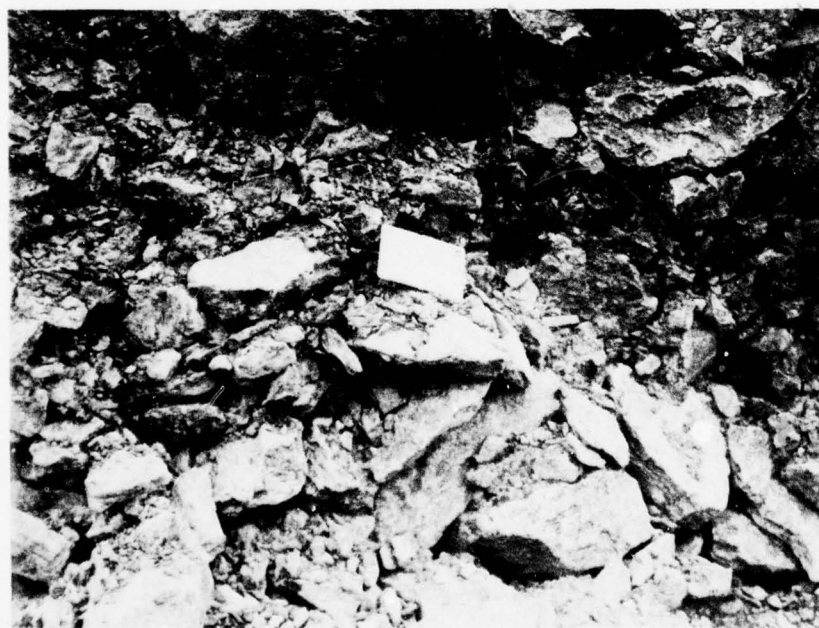
Fig. 44. Inspection trench, test fill 3, New Melones test fill

a. Section of rock test fill 3
(minus 6-in. unweathered rock transition)

b. Closeup view of rock test fill 3
(minus 6-in. unweathered rock transition)

- (2) An examination of test fills 2 and 3 (minus 6-in. rock) revealed some tendency toward stratification of the rock fragments. Dumping and spreading operations were probably the major cause of the stratified appearance; although it was noticed that during compaction of test fill 2 (weathered material), the surface material was reduced to a fine-grained material similar to a soil. As the rock was dumped and spread by dozer, the coarse rock rolled ahead and to the sides of the pile, resting on top of the previously compacted surface of the lift below and forming a thin layer of segregated coarse material at the lift boundary. Interlocking between lifts was generally poor, due to the coarse material overlying the extremely smooth surface of the underlying lift. Photographs of the trench through test fills 2 and 3 are shown in figs. 43 and 44.

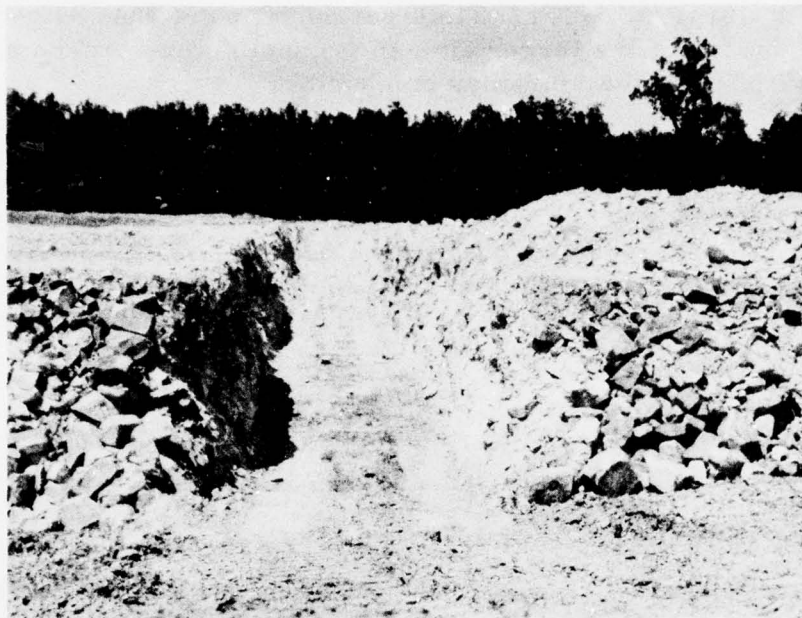
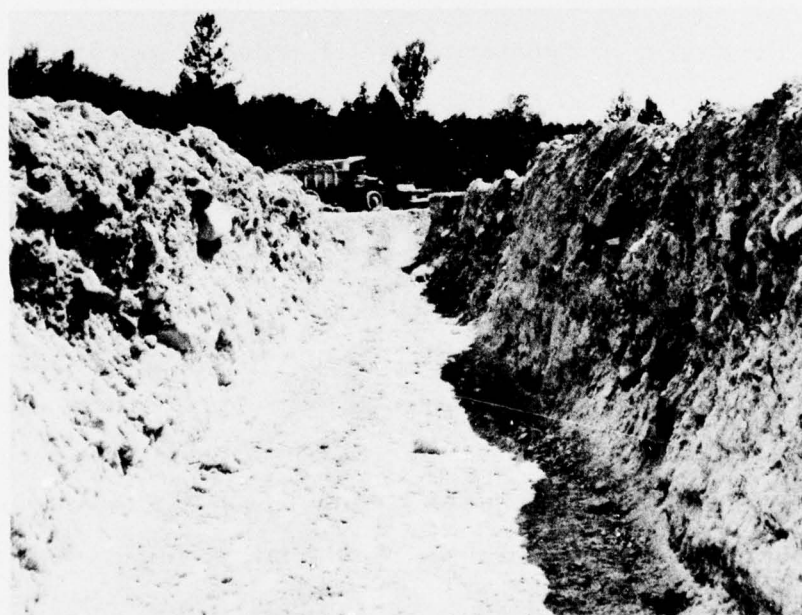
Fig. 59. Inspection trench, Gillham test fill

a. View north, inspection trench excavation

b. View south, inspection trench excavation

- d. Inspection trench. Visual examination of the inspection trench confirmed the tightness and unusually high degree of stability of all compacted material. No mention was made of any segregated or stratified zones or that any evidence of poor bonding between lifts was found. Two views of the inspection trench are shown in the photographs in fig. 59.
